SERVICE BULLETIN 111

REDUCTION OF FORCE REQUIRED TO OPERATE PARACHUTE TYPE TOP VENTS

Revision A

DRAWING AMENDMENT NO. 145 SH. 1 OF 1 DATE 3-25-80 1K

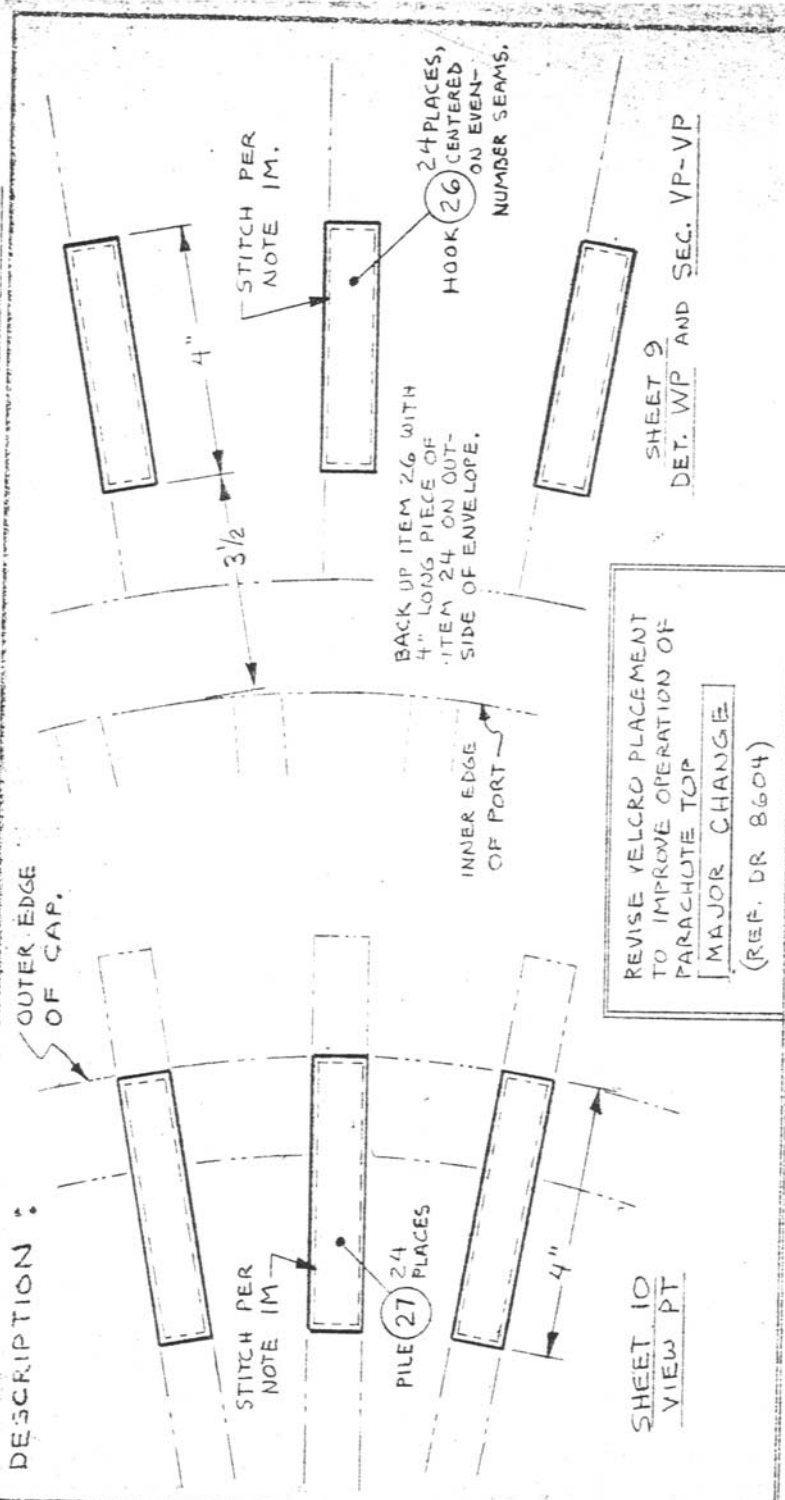
Recently manufactured balloons having parachute tops with 4" long vertical positioning tabs are in compliance with FAR 31.57B and need not be modified. These balloons have a full 4" of hook and pile and should be left as such with NO SHAVING OF EITHER HOOK OR PILE NECESSARY OR INTENDED. This includes all balloons manufactured and tested at Raven Industries on or after March 13, 1980.

REVISE VELCRO PLACEMENT TO IMPROVE OPERATION OF PARACHUTE TOP
 MAJOR CHANGE
 (REF. DR 8604)

Remove the pieces of Velcro hook located directly below the deflation port and relocate by sewing the 4 inch long 1 inch wide pieces of Velcro hook in position such that the 4 inch pieces of Velcro hook are located vertically on the even numbered half gore seams with one end located 3½ inches and the other end located 7½ inches from the edge of the deflation port. This positioning of the pieces of Velcro hook is oriented 90° from that of the original design.

Remove the pieces of Velcro pile located on the parachute top and relocate by sewing the 4 inch long 1 inch wide pieces of Velcro pile in position such that one end of the 4 inch pieces of Velcro pile is located even with the edge of the parachute top and that the other end of the four inch piece of Velcro pile is located four inches from the edge of the deflation cap. Again, this new positioning of the Velcro is oriented 90° from that of the original design.

STITCH PER NOTE 1M

PILE (27) 24 PLACES

BACK UP ITEM 26 WITH 4" LONG PIECE OF ITEM 24 ON OUT-SIDE OF ENVELOPE.

HOOK (26) 24 PLACES, CENTERED ON EVEN-NUMBER SEAMS.
