AEROSTAR SERVICE BULLETIN #123A

AUGUST 28, 1989

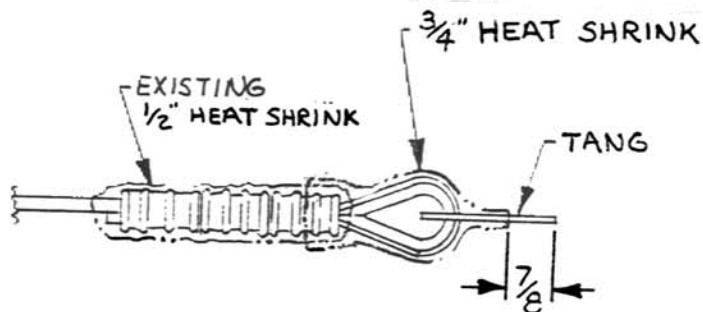
- SUBJECT:** AFT Cables using the Web Davis fittings are affected, except those tangs shown in the diagram with .45" holes in both ends do not apply.
- PROBLEM:** The tang used to join the AFT cables to the Web Davis fitting may be susceptible to kinking or bending during inflation. The tang may get jammed thus putting undue stress on that cable.

- DISCUSSION:** It was noted by an owner of AFT cables that during inflation while the cables are loose, the tang is allowed to slide freely in the thimble (loop) of the AFT cable. As hot air is added to the envelope, the tang may get crossed-up in the thimble and could kink or bend the tang.

- CORRECTIVE ACTION:** A short length of heat shrink tubing is to be added to center the tang in the thimble.
- PROCEDURE:** The only tools needed will be a hot air gun and torque wrench. Remove AN bolt that connects the tang and Web Davis fitting. Slide the heat shrink tubing over the tang and thimble. See schematic below for placement of the heat shrink tubing. Re-install bolt and torque nut to 35-45 in-lbs. Continue procedure to remaining AFT cables. Log as preventive maintenance compliance with FAR #41 Appendix A 10, 12, and 28.
