AEROSTAR SERVICE LETTER 103

11/01/90

- Subject:** Springtop paravent modification
- Applicability:** Aerostar RX-7; Date of manufacture from 5/86 to 11/90.
Aerostar RX-8; All models manufactured before 11/90.
S55-A, S57-A, S60-A; Date of manufacture from 9/88 to 11/90.

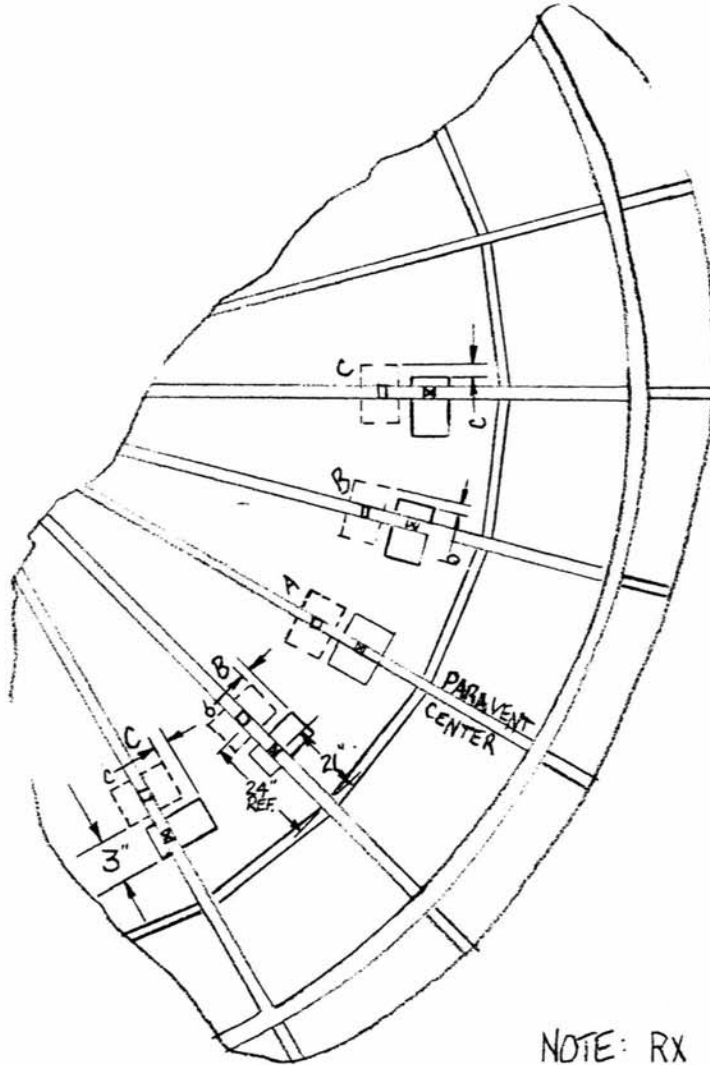
FIGURE

- Problem:** Recent field reports have indicated that a very small number of Springtop paravents have not been sealing completely, resulting in higher than normal fuel consumption rates.

- Discussion:** This problem is related to changes which occurred during Springtop standardization. The alteration of certain dimensions may have made the fit of the paravent more sensitive to shrinkage and/or elongation of the top-cap fabric. Although these balloons did not leak when they left the factory, normal use may have resulted in shrinkage and/or elongation of the top-cap fabric causing minor leaking or stress in the vent area in a limited number of cases.
This modification is not required, and is probably not necessary for the majority of balloons in service. However, if the operator has experienced

- 1) First, verify that the distance from the box-x (connecting overstrap to top-cap) to the first circumferential "spider web" in the port along the radial measures 24 in. +/- 1 in. (See Fig. 1) If this dimension is not met, the balloon is not affected by this service letter.

- 2) Measure three inches radially outward (towards the port edge) from the box-x location on the overstrap, and make a mark. (3 locations RX series, 5 locations S series).

- 3) Carefully remove the box-x stitching which connects the overstraps to the top-cap.
- 4) Refer to Figure 1. Except for the center (A) reinforcement patch, the box-x is not re-sewn to the middle of the patch, but is offset as shown. The object of this offset is to preserve the fullness in the vent area of the top-cap; thus the patches are moved towards the center of the vent. Identify each patch as (A), (B), or (C) and mark the offset on the patch.

- 5) Using a single needle machine with "F" thread, (6-9 stitches/in., thread type V-T-285 polyester, Type I or II, Class 1 or 3), sew a box-x connecting the top-cap to the overstrap at the marked locations.
