**AEROSTAR INTERNATIONAL, INC.  
SERVICE LETTER 107**

NOVEMBER 7, 1994

**SUBJECT:** CLASSIC X (RB8) BASKET, FLOOR PLATE

**APPLICABILITY:** Basket Serial Numbers RB8-101 through RB8-113

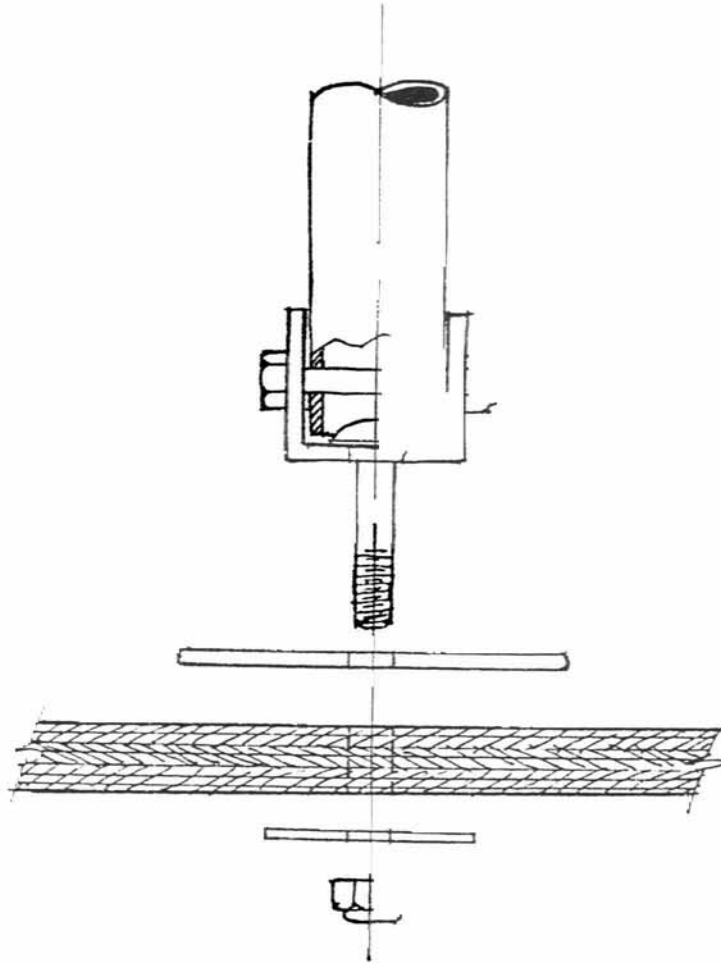
Illustration One

**PROBLEM:** There have been reports of some damage to the plywood floor beneath the vertical tube or post at the intersection of the divider panels (two places, either side of the pilot compartment).

**DISCUSSION:** Upon further evaluation, it was found that the tensioning of the divider panels at the time of manufacture was creating a good deal of compression at this post. This results in a prestressing of the plywood floor panel.

During landing impact, the combination of this concentrated stress, shock loading, and a fairly small bearing area under the post itself, could result in localized damage to the plywood. An increase in the bearing surface area was the simplest cure. An aluminum plate was produced to insert between the post base and the floor. New bolts and locknuts are also provided as the existing ones may not be reusable.

**PROCEDURE:** Remove the AN3 bolt and locknut holding the tube to the U-bracket at the floor (save bolt and nut for re-use). Slide tube to side of bracket (away from pilot compartment). Install aluminum bearing plate (washer) between U-bracket and plywood floor. Install new carriage bolt and locknut, re-use existing fender washer. Do not tighten fully until tube is reinstalled.

Reposition tube in U-bracket and tighten AN3 bolt and locknut. Note that it may be necessary to apply considerable leverage to reposition the tube due to the tension in the adjacent dividers. Tighten 5/16" nut on underside of basket. Then cut off excess bolt threads and grind smooth.

Repeat the procedure at the other post location.
